# BISMARCK PARKING AUTHORITY

## MEETING AGENDA June 13, 2024

2. Review Financial Statements
3. CW Structural – Ramps General Condition Assessment – Derek Kost

Re: Bismarck Parking Authority Ramps – 2024 General Structural Condition Assessment

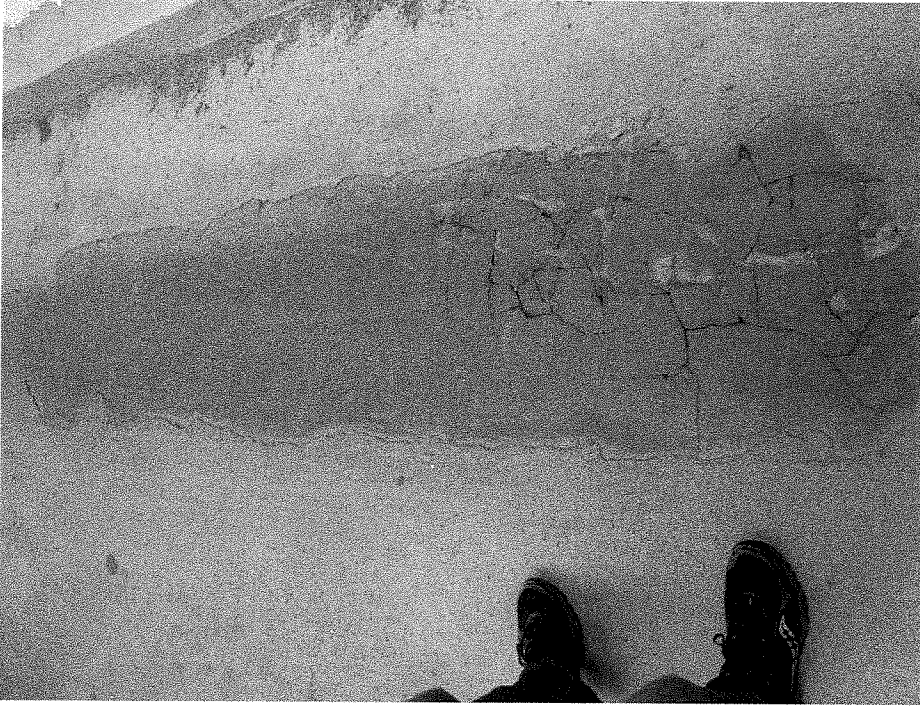
1. Ramp Entrance Slab
  - a. *Top Surface of Slab Traffic Coating & Patch Deterioration* - Very significant wear was observed on the traffic coating, with most of the wear being observed in the vehicle wheel tracks and where the wheels of each vehicle stop and start at the ticket machine. (See Figures #1 & #2). The traffic coating has been completely worn through at many locations along the wheel tracks, with wear increasing year-to-year due to the significant amount of traction needed by vehicle to enter the ramp and from starts/stops at the ticket machine gate. This is a very high traffic area that requires continued traffic coating maintenance to ensure protection of the underlying concrete. Bubbled up & damaged areas of traffic coating were recently cut away, revealing cracks & underlying surface delamination in the concrete at previously patched areas. These cracks at various areas appear to be allowing moisture to penetrate through the slab, likely causing additional corrosion and concrete damage to occur from freeze-thaw cycles at both the top and bottom surfaces of the slab.

**Figure 1:** Parkade Ramp Entrance– Damaged traffic coating was cut away, revealing concrete delamination in prior patch. This correlates to moisture infiltration in the mechanical room below.

- Priority A1 – Entrance Ramp Concrete Repair and Traffic Coating Replacement
  - Concrete Ramp Entrance Slab Repair. (\$30,000 Concrete & \$25,000 for FRP Repair = \$55,000 Total)

- The existing traffic coating on the entrance ramp should be completely removed, with all underlying concrete patched and repaired to sound concrete. The underside of the ramp slab was previously reinforced with FRP strips adhered to the slab. These FRP strips were observed to be holding some spalled concrete in some locations, at the east end of the ramp, in particular. The FRP is to be repaired & reinstalled as required after repairs.

- Re-install New Traffic Coating (\$30,000 Traffic Coating)
    - A new high quality traffic coating is to be applied at the entrance ramp. The traction needed by vehicles to get up the steep incline, as well as starting and stopping at the ticket machine, results in significant wear on the traffic coating at this location. A very high quality, durable traffic coating is required from the start of the ramp entrance up, past the gate arm, to the yellow level within the ramp.

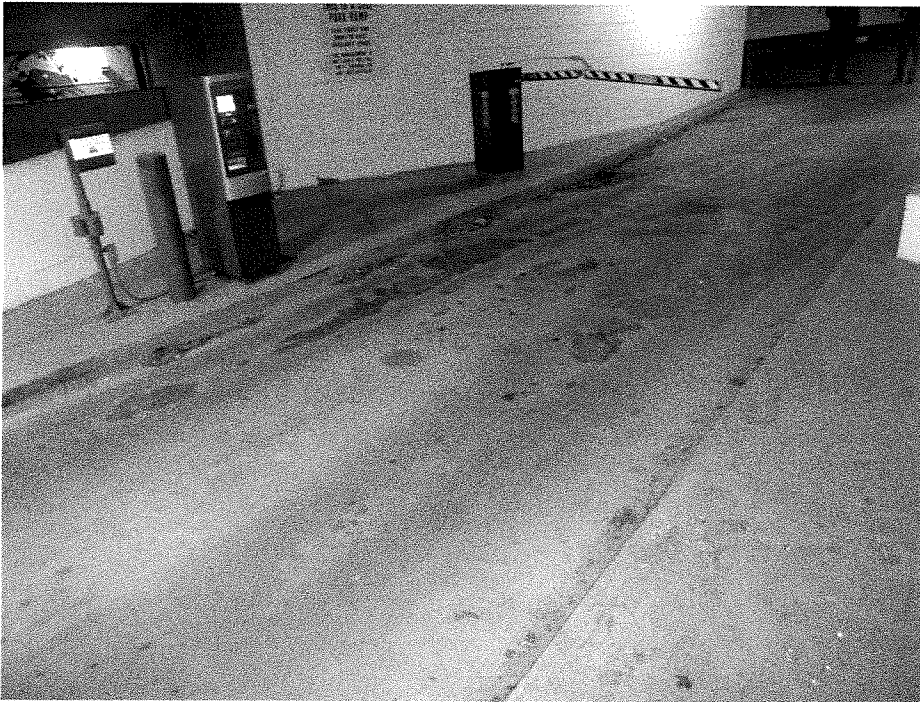
**Figure 2:** Parkade Ramp Entrance – Ticket machine gate. Traffic coating is worn through along wheel tracks all along the ramp entrance.

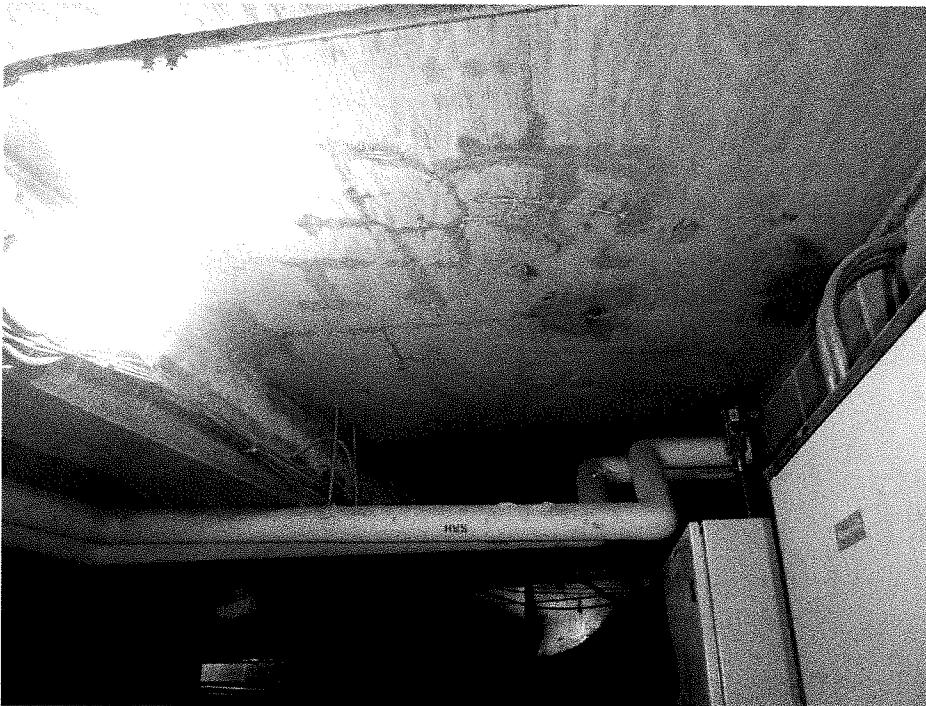
- c. *Bottom Surface of Slab Patch Cracking (Above the Air Handler Room & Storage Room)* – Past concrete patch repairs were made to the ceiling slab overhead in the air handler room and the storage room that are both located west of the lower-level mechanical room. Minor cracking and moisture within these patches were observed, suggesting continued moisture infiltration & corrosion after these repairs were made, likely due to moisture and chlorides infiltrating the ramp entrance slab from above due to failed traffic coating. The air handler room appears to roughly correlate to the base of the entrance gate arm and floor drain above. The back storage room appears to roughly correlate with the wheel tracks west of the entrance gate arm. While these wheel tracks are sheltered from rain from above, it is believed that vehicles may be tracking in significant water & chlorides atop the slab that is infiltrating the slab at unprotected areas where the traffic coating is significantly worn away (Figures 4 & 5).

Figure 4: Parkade Ramp – Previous concrete repair patch in air handler room (below ramp entrance) showing cracking & moisture infiltration.

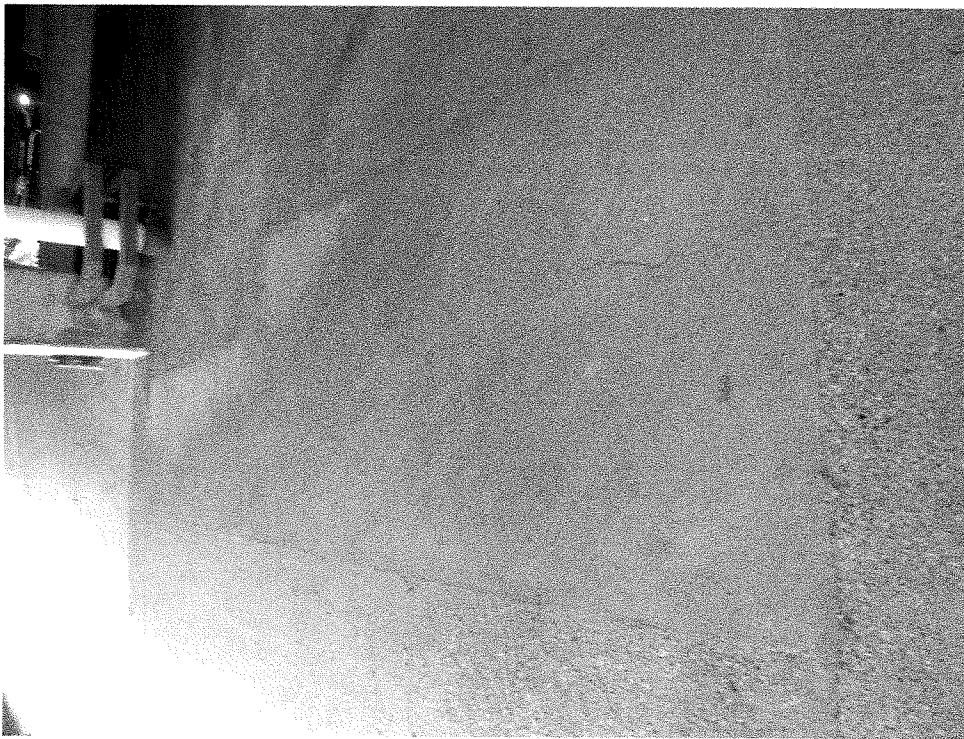
- a. *West End Slab Patch Cracking* – A large area of slab was recently patched within the last year and is located just after turning into the west end of the blue level from yellow level (See Figure #6). The patch replaces a non-uniform previous patch that was failing. The new patch area has clean, rectangular sawcut edges from the recent repairs, however shrinkage cracks appear to have formed within the patch, which have since been routed and caulked. It is unknown if these cracks formed immediately or over time, but the concern is that moisture may be able to penetrate the cracks and deteriorate the slab over time during freeze-thaw cycles without a traffic coating if caulking is not maintained.

Figure 6 – Parkade Ramp – Yellow to Blue Transition – Recently patched concrete, within past year or two with shrinkage cracks that have been routed & caulked.

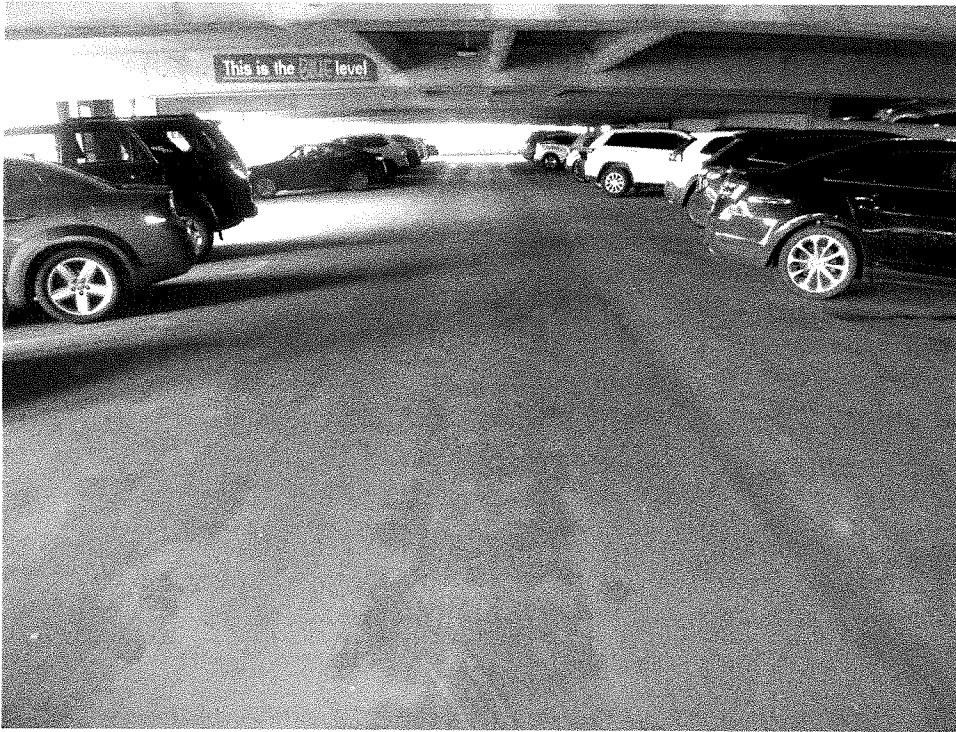
- b. *Entire Blue Level Traffic Coating Age* - There is an older black traffic coating on the blue level, however, this coating has been worn away from traffic at the drive lane and areas of spalls and irregular shaped patches are present at the construction joint from vehicle traffic (See Figure #7).

Figure 7 - Parkade Ramp – Blue Level – Old traffic coating worn away at drive lane.

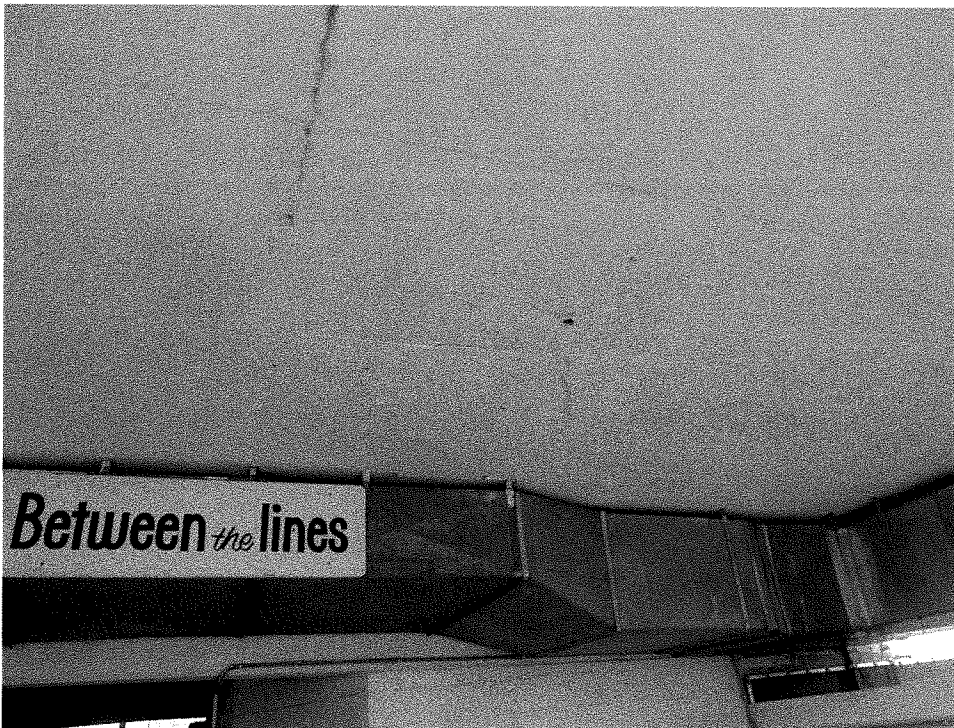
- c. *Bottom of Slab Corrosion* - NE corner of Blue Level (Underside of Blue Level Slab located above ticket gate below) A recent overhead patch near the ticket machine on the underside of the blue level above continues to show some cracking and minor brown discoloration, likely from rust & corrosion of internal rebar (Figure #8). Corrosion may be continuing from standing water above. A daylight drain outlet had been cored into the slab during previous repairs to allow water to drop to the level below. However, it is unclear on how well this drain has been functioning and if the water is able to make it to the drain or allowed to pool. Debris was observed around the drain at the level above during our visit. This potential corrosion should be monitored.

Figure 8 – Parkade Ramp – Underside Blue level slab above entrance ticket gate. Signs of potential corrosion with brown discoloration.

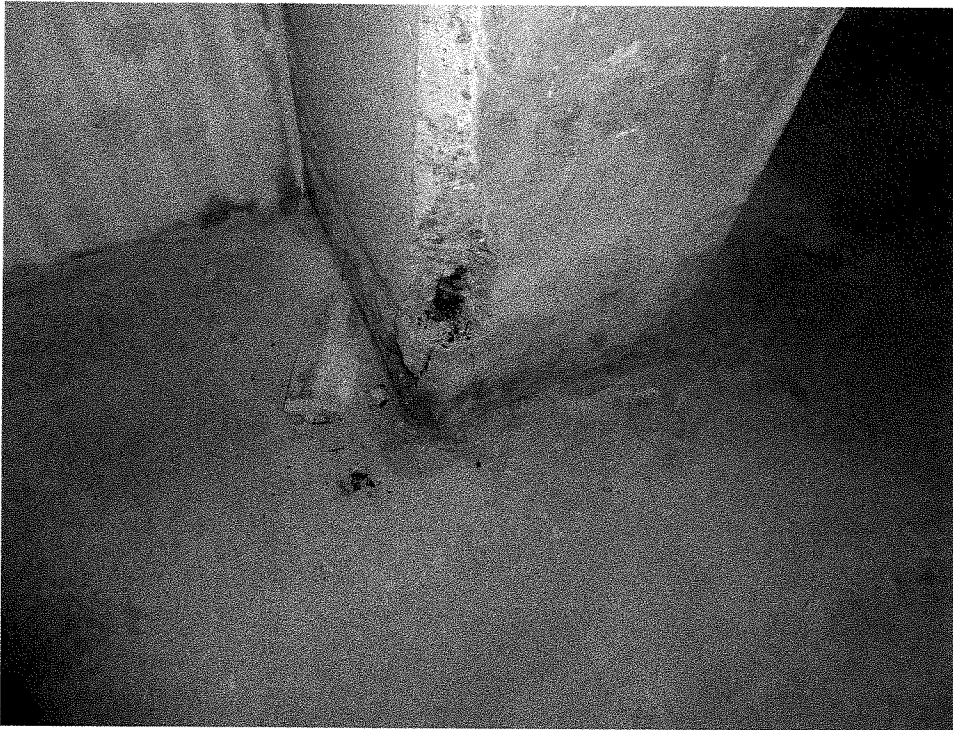
- a. *South Wall Column Base Spalling & Corrosion* - Concrete spalling and corrosion are present at the base of multiple columns along the south perimeter railing wall at the green level (See Figure #9).

These column spalls are caused by the reinforcing inside the column corroding & rusting which then expands and spalls the concrete. It is believed that this corrosion may be occurring due to water & snow being present & potentially pooling adjacent to the columns at the south wall. Lack of traffic coating protection up the base of the column may allow corrosion to occur due to moisture & chlorides.

Figure 9 – Parkade Ramp – Green Level column at south side of the ramp. Base of multiple columns show signs of rebar corrosion and concrete spalling due to consistent exposure to moisture along south wall.

- Priority B – Green Level South Half
  - General Concrete Repairs & Traffic Coating (\$50,000 Concrete Repairs & \$85,000 Traffic Coating)
    - With recent completion of immediate structural concerns, at the green level, it is recommended that the balance of recommended basic concrete slab repairs be completed at the south half of the green level, with a traffic coating applied over this area to provide complete repair and protection of this section of the ramp. Areas requiring repair were sounded by Walker Consultants during their condition assessment and it is recommended that all concrete repairs be made and ultimately protected with a traffic coating to minimize future corrosion potential that previously resulted in a broken tendon at this level.

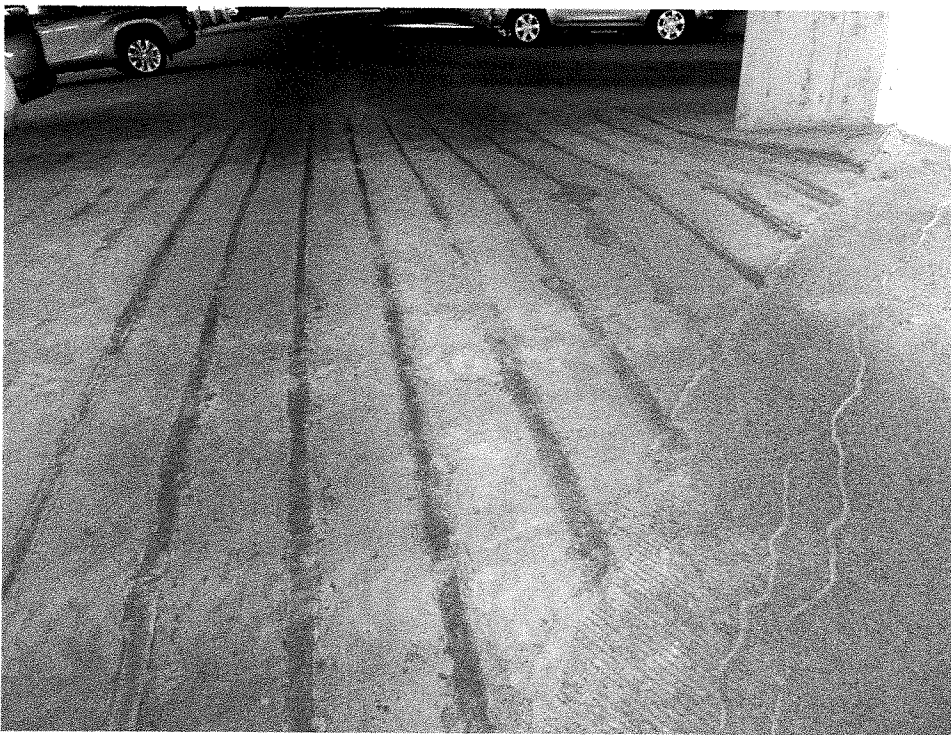
- b. *Protection of Previous Green Level Repairs* – As part of recent Green Level repairs within the last two years, the east end of the ramp, adjacent to the exit spiral opening, was repaired with epoxied rebar into the slab. The next step in this repair was to provide protection of these bars & repairs with a traffic coating (See Figure #10). Note that the application of this traffic coating has been delayed as it was presumed that the balance of green level concrete repairs would be completed prior to traffic coating this area, but the ultimate final recommendation is to protect these repairs with traffic coating.

Figure 10 – Parkade – Green Level – (Photo from 2022) Recent epoxied rebar repairs near exit to spiral. Required next step is protection of these repairs with traffic coating.

- Priority A2 – Green Level
  - Protect Recent Repairs via Traffic Coating (\$15,000 Estimated Repair Cost)

- Concrete repairs were made at the east end of the green level with concrete patching and added rebar in epoxied slots within the concrete. Traffic coating is recommended to be added over this small area (approximately 40' x 60' area) to protect these recent repairs from moisture infiltration.

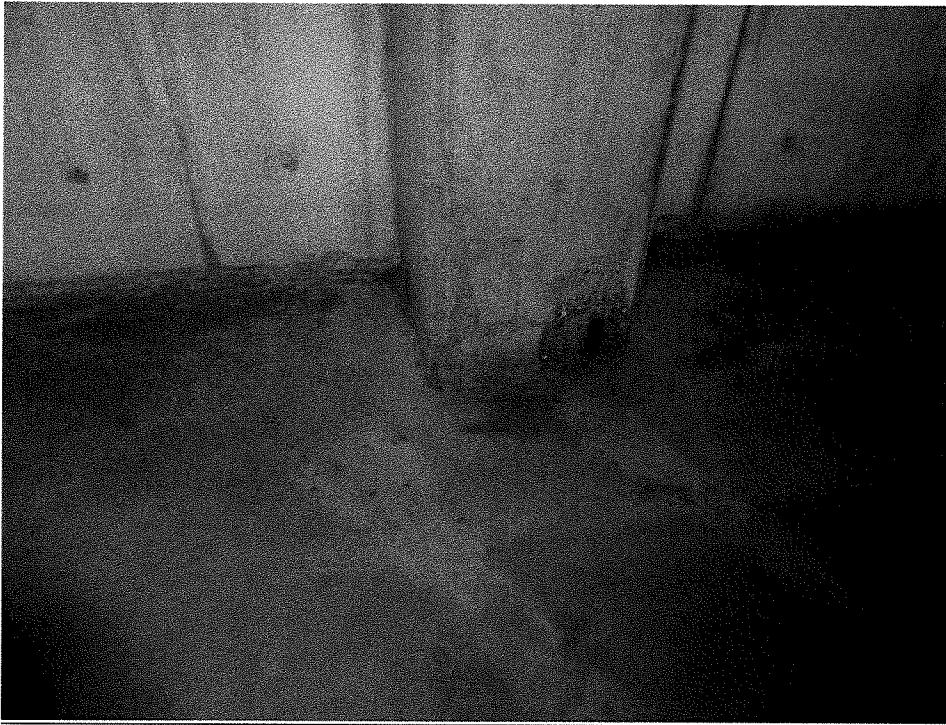
- a. *South Wall Column Base Spalling/Corrosion* – Similar to what was observed at the columns at the green level, some columns along the south wall of the Parkade at the red level were observed as having corrosion of reinforcement within the column, resulting in concrete spalling at the base of the column (Figure #11). As seen in the photo, it appears that moisture pools and sits adjacent to these columns and could be contributing to the corrosion.

Figure 11: Parkade – Red Level – Spalling at corner of column

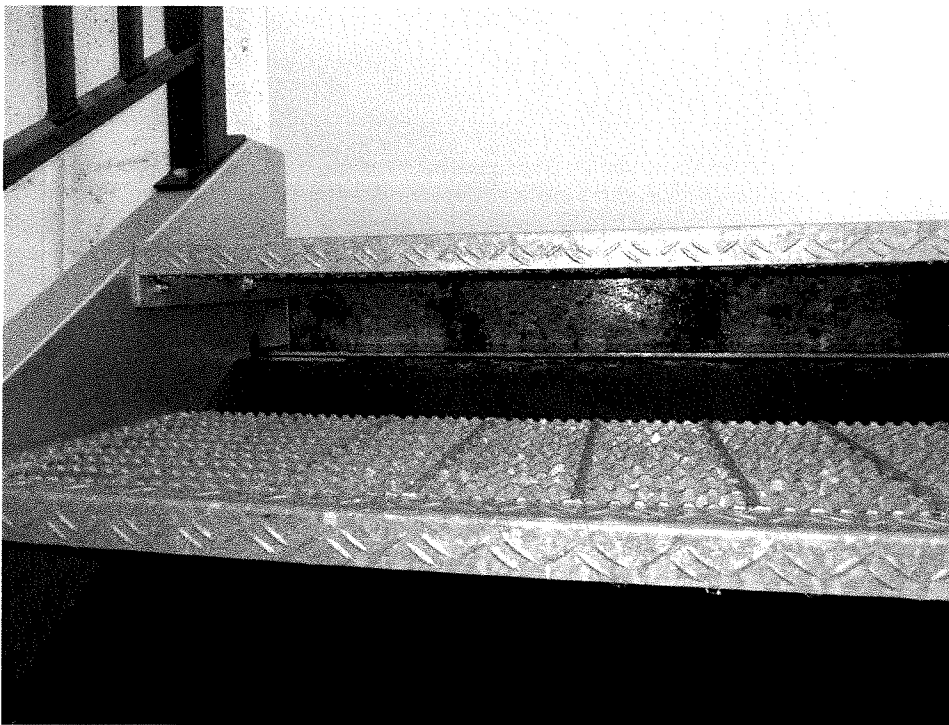
- a. *Corrosion on Newly Installed Steel Stairs* – Within the past year, new exterior stairs were installed at the Purple/Roof Level to replace the severely corroded concrete stairs that were present. These stairs appear to be of steel construction with galvanized steel treads and painted steel channel stringers with standard zinc plated fasteners. It was observed that corrosion has already begun on the painted steel stringers at the base of the stair and where the structural steel bears on the existing concrete at the top of the stair (Figures #12 & #13). Standing rain/snow and moisture at these components likely contributed to their corrosion as the stairs are completely exposed to the elements. Galvanic corrosion can occur between various combinations of dissimilar metals & finishes in the presence of moisture. For best performance against corrosion, the selected components & fastener materials with high-performance finishes should be utilized. The original stair supplier may need to be consulted to determine what improvements may need to be made to this newly placed stair to better protect it during its lifetime as the immediate corrosion is expected to likely continue at a rapid pace.

Figure 12: Parkade – Roof Level - New exterior roof stair showing steel corrosion atop the existing concrete at the top of the stair.

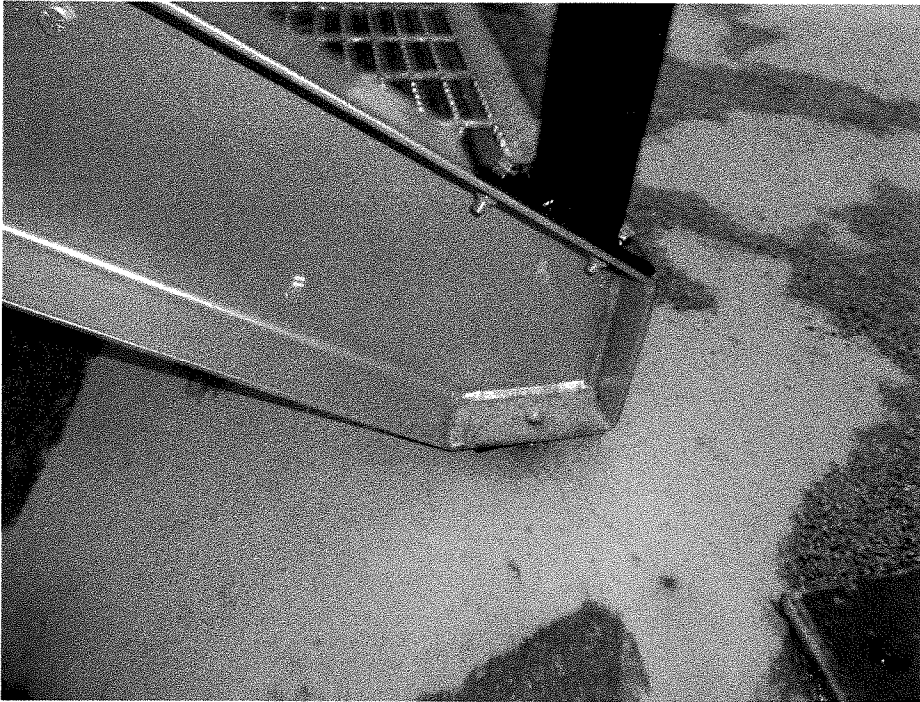
Figure 13: Parkade – Roof Level - New exterior roof stair showing steel corrosion at the base of the stair channel. This is typical at the base of both stair channels.

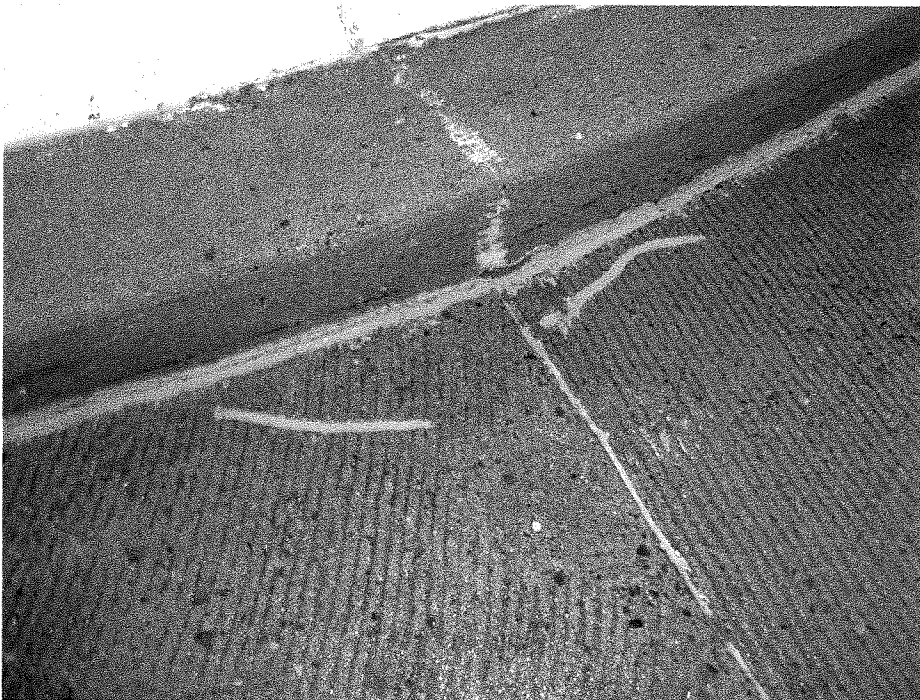
- a. *Original Construction Joint Protection* – Recent repairs were completed at curved concrete beams that lead into each entrance on the exit spiral. As mentioned in previous inspections, there have been signs of corrosion in the form of visible brown stains & damaged paint at the underside of many of the original construction joints of the railing walls/beams and the slab. However, no concrete spalls, delaminations or cracking was observed, so this is to continually be monitored. It was raining during our site visit and it was observed how the water runs down the inner curb & gutter of the spiral. Improved calked cove sealant along this gutter and at the original slab/railing construction joints where they meet the inner gutter may provide additional protection from corrosion as it was observed to be inconsistent down the spiral, with some areas of caulking failure present (Figure #14).

Figure 14: Parkade – Typical caulking at inner curb of exit spiral at original slab construction joint.

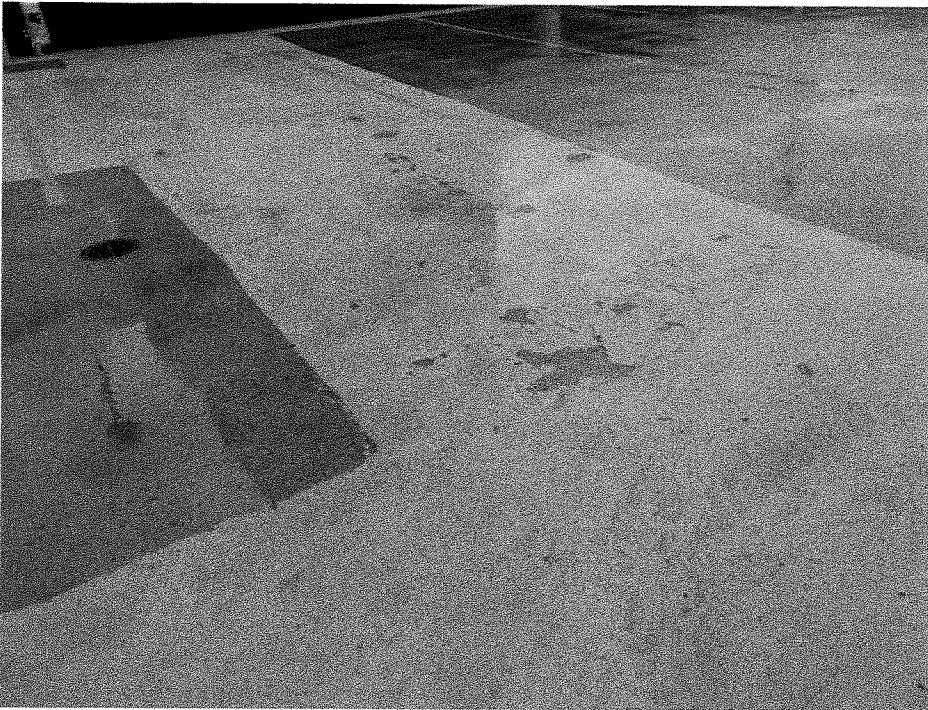
- a. *Roof Level Traffic Coating* - Roof level slab repairs were made in the past. The condition of the traffic coating over this area was noted as having some larger damaged areas, likely from snow removal equipment (Figure #15). It is recommended that this be repaired to continue providing the protection from moisture as intended. Periodic maintenance may be required to prevent water infiltration as wear and tear increases.

Figure 15: Galleria – Damage at existing traffic coating protecting recent repairs.

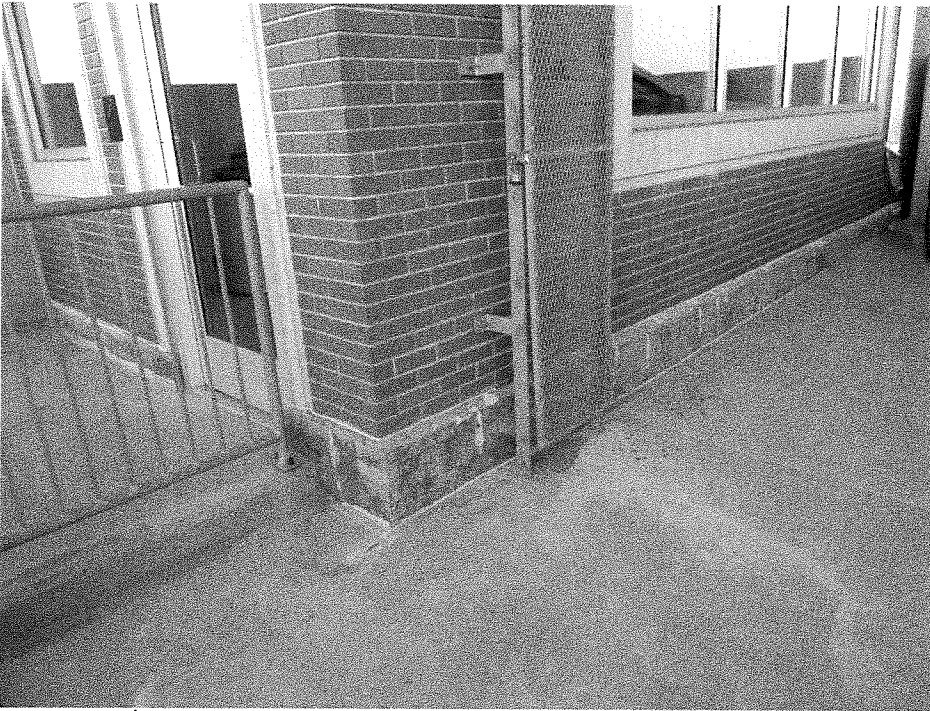
- a. *Stair Tower Wall Finish* - The southwest stair tower shows some moisture infiltration & potential corrosion within the base of the precast concrete wall panel architectural finish surrounding the north and east sides of the vestibule at the roof level (Figure #17). It is uncertain if the base of this panel may have been concrete that was formed and cast-in-place after placement of the precast wall panels to potentially conceal precast connection. It is unclear how moisture is infiltration the panel so uniformly across the entire wall.

Figure 17: 6<sup>th</sup> Street Ramp – SW stair tower at roof. Signs of moisture and concrete corrosion at base of concrete wall panel.

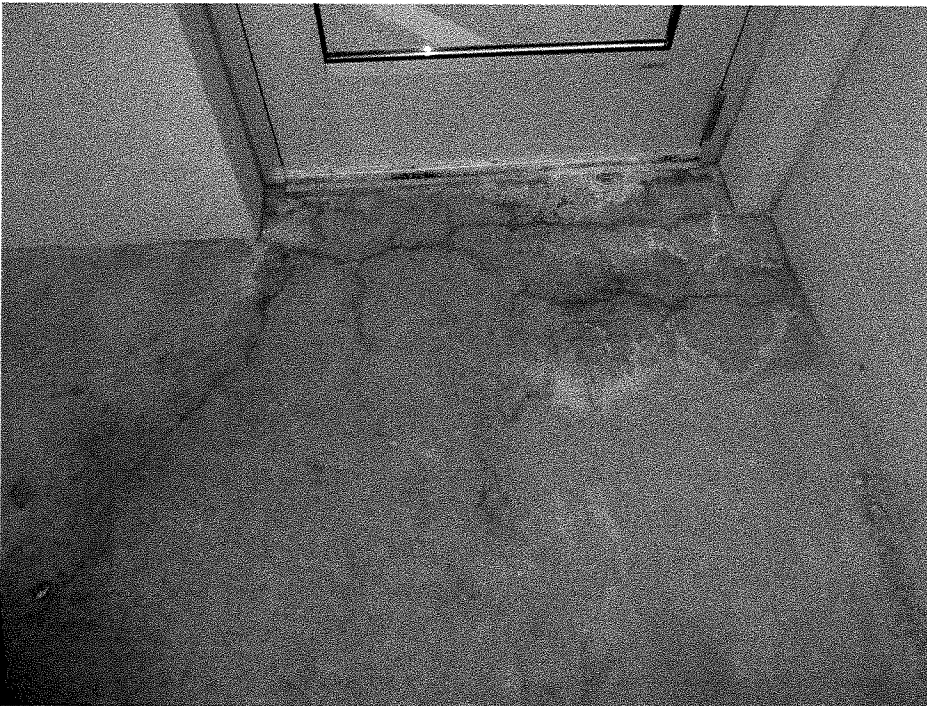
- b. *Stair Tower Entrances* – Moisture appears to be able to be wind driven into the various levels of the stair towers (Figure #18). It was observed that the base of the doors consist of at fiber broom-like sweep rather than any type of rubber gasket. It is advised to consult with an architect or door supplier on other options of door sweeps that can be provided to keep water out of the vestibules.

Figure 18: 6<sup>th</sup> Street Ramp – Typical vestibule door with bristle brush sweep that allows wind-driven moisture into the vestibule.

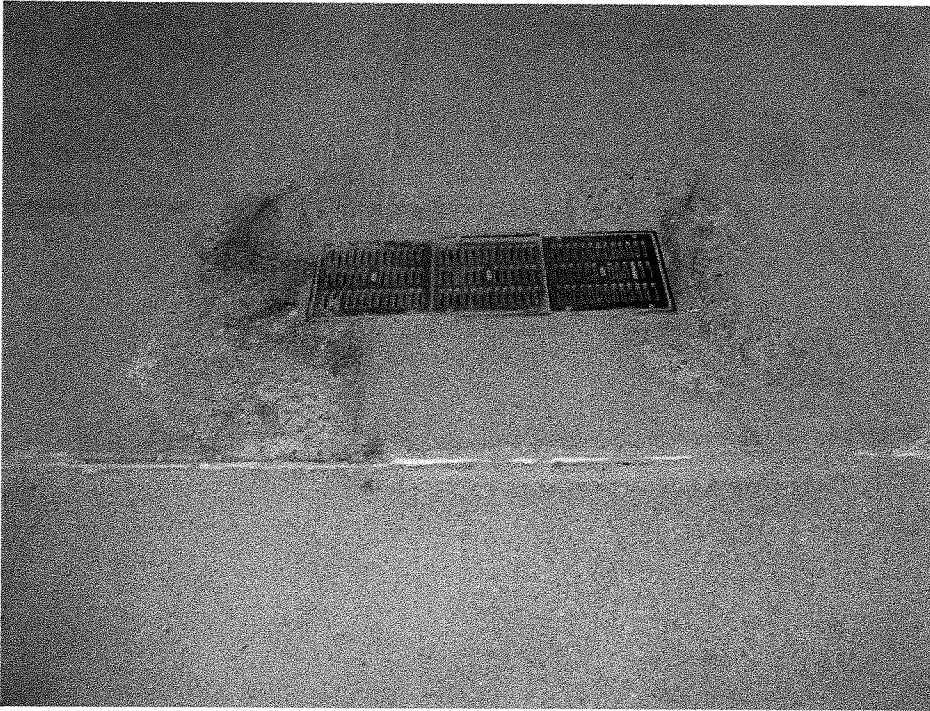
- a. *Slab-on-Grade Spalling at Entrance* - As mentioned in previous inspection reports, the concrete slab-on-grade around both the entrance floor drains remains badly spalled, potentially from vehicle traffic or freeze thaw movement adjacent to the drain, or a combination of both (Figure #19). However, this remains relatively unchanged from previous years. It would appear that the drains are not able to collect much moisture runoff in their current condition and the water likely pools around the drain resulting in further concrete damage over time. As this is slab-on-grade, this is not a structural concern.

Figure 19: 3<sup>rd</sup> Street Ramp– Typical slab spalling around drain grate at west entrance. Typical at two entrance grates.
